MERRIMACK RIVER BASIN  
HUDSON, MASSACHUSETTS

MAIN STREET DAM  
MA 00448

PHASE I INSPECTION REPORT  
NATIONAL DAM INSPECTION PROGRAM

MAY 1979

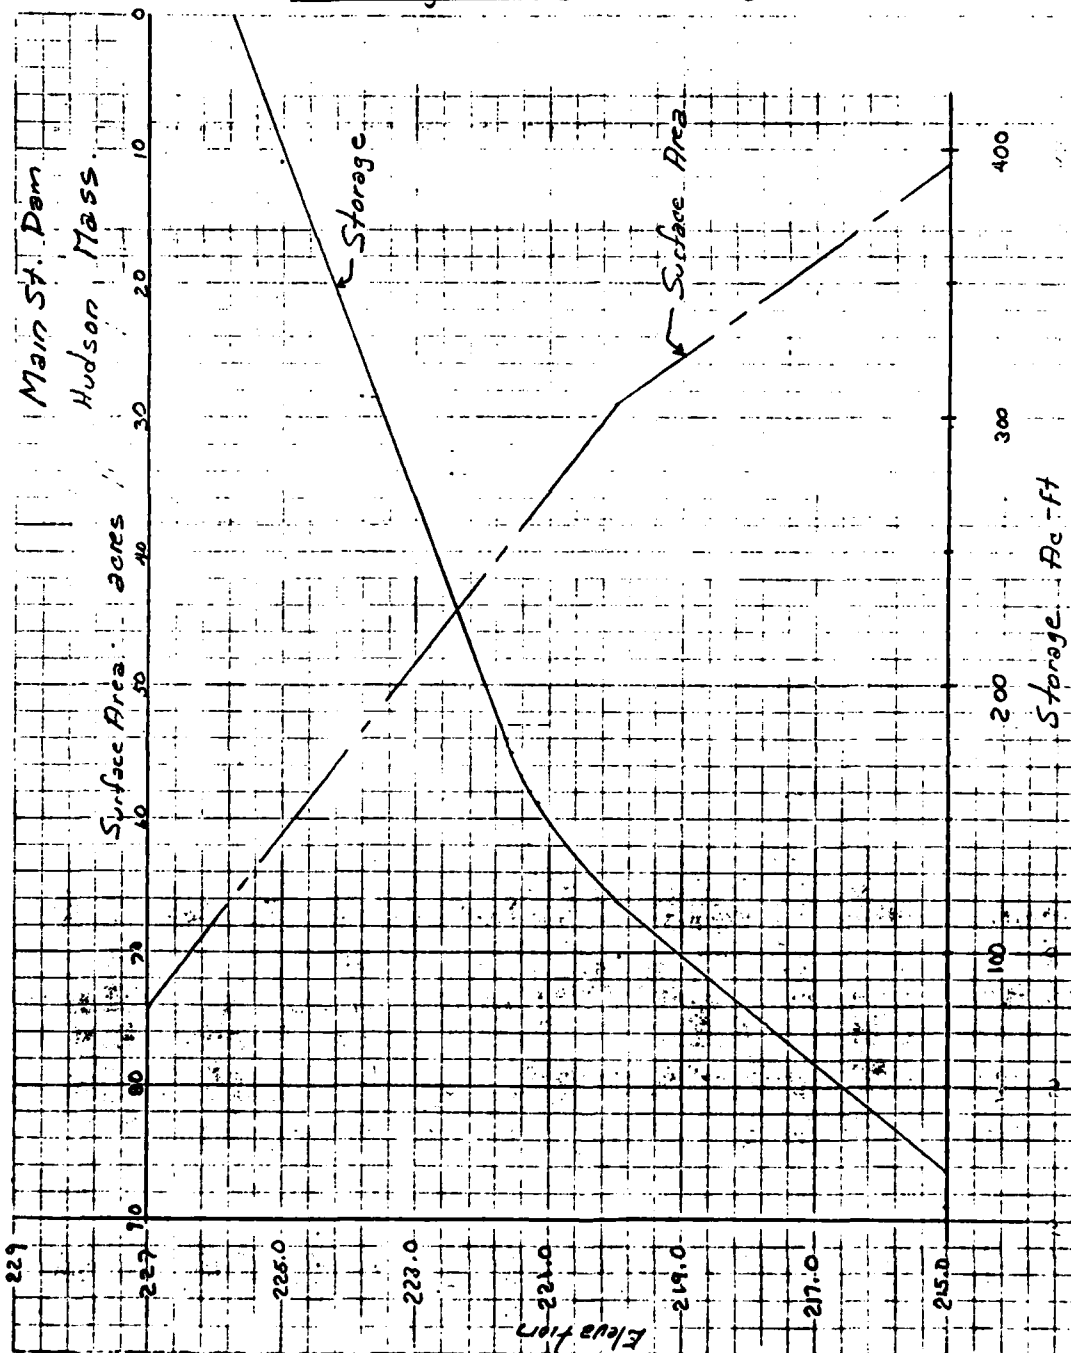
CLIENT C of E  
 PROJECT Main St Dam  
 DETAIL Test Flood

Based on the size classification, small, and hazard potential classification, high, in accordance with Corps of Engineers Guidelines, the adopted spillway test flood is the 1/2 PMF (Probable Maximum Flood). Hydraulic analysis indicates that the spillway capacity at top of dam is approximately 460 cfs which is about 24 percent of the total test flood of 1900 cfs. The estimated test flood stage is about 3.3 feet above the top of dam.
